CITY OF BALTIMORE
SMOKE TESTING OBSERVATION SUMMARY
LOW LEVEL SEWERSHED
BALTIMORE CITY PROJECT 1029
REI/DRAYCO

Unique Test ID: 589	Date: 09/03/2008	Basin: LL - 44	Manhole ID: S19I__010MH
Defect No: OB01	Supervisor: E.R.	Crew: 04	Dye Test Recommended: N
Location: 4 S. PAYSON ST.

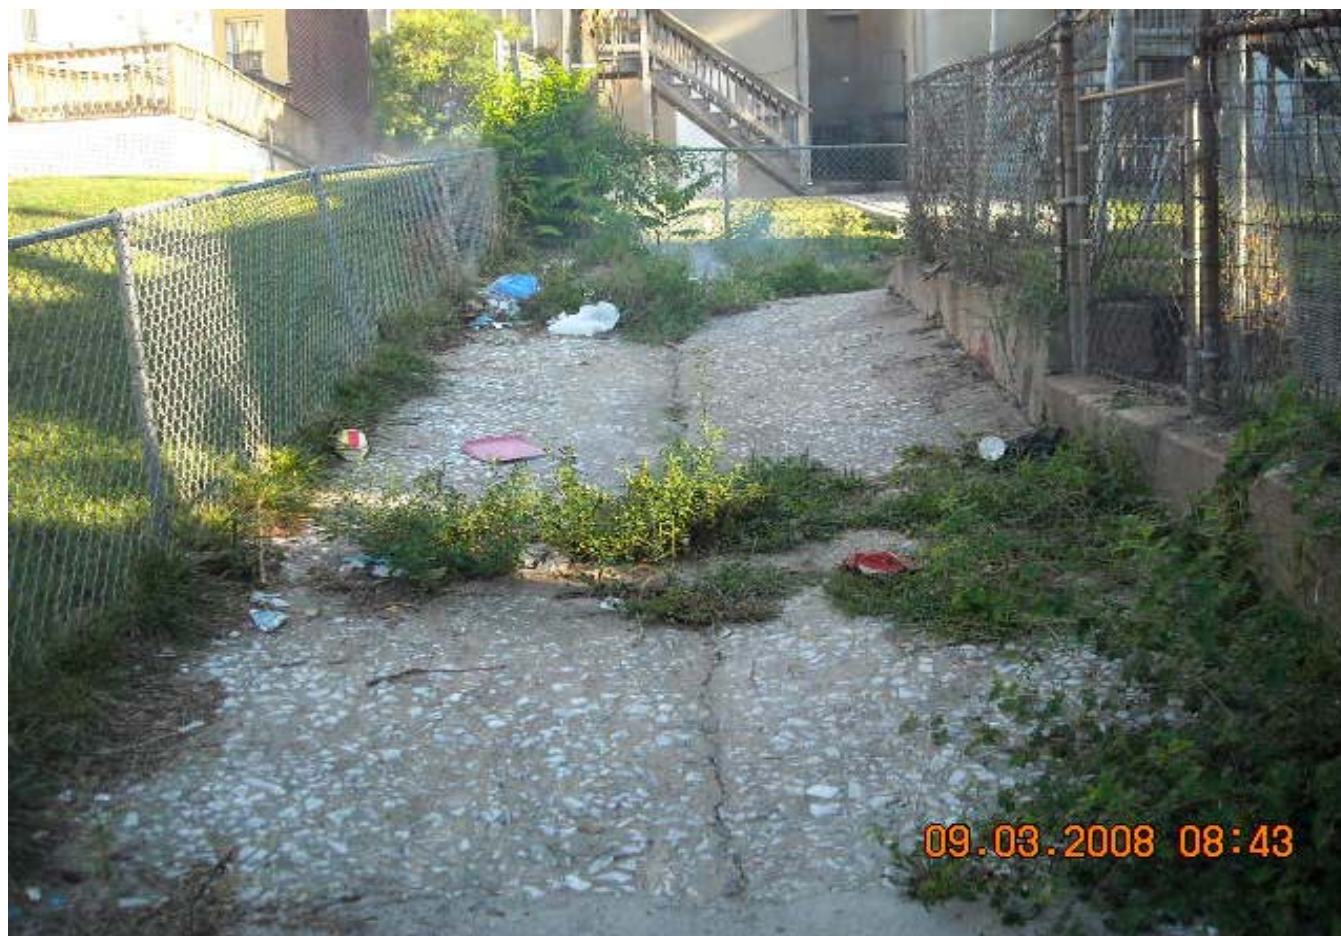
Photograph No: OB01-01
Filename: 1029-589_OB01-01.jpg

Source Type: 01 Main Sewer

Sector: 01 Public

Location: 12 Alley

Severity: 03 Moderate

Comments: SMOKE IS COMING FROM THE MIDDLE OF THE ALLEY ALONG MAIN SEWER LINE. DEFECT IS BEHIND ADDRESS.

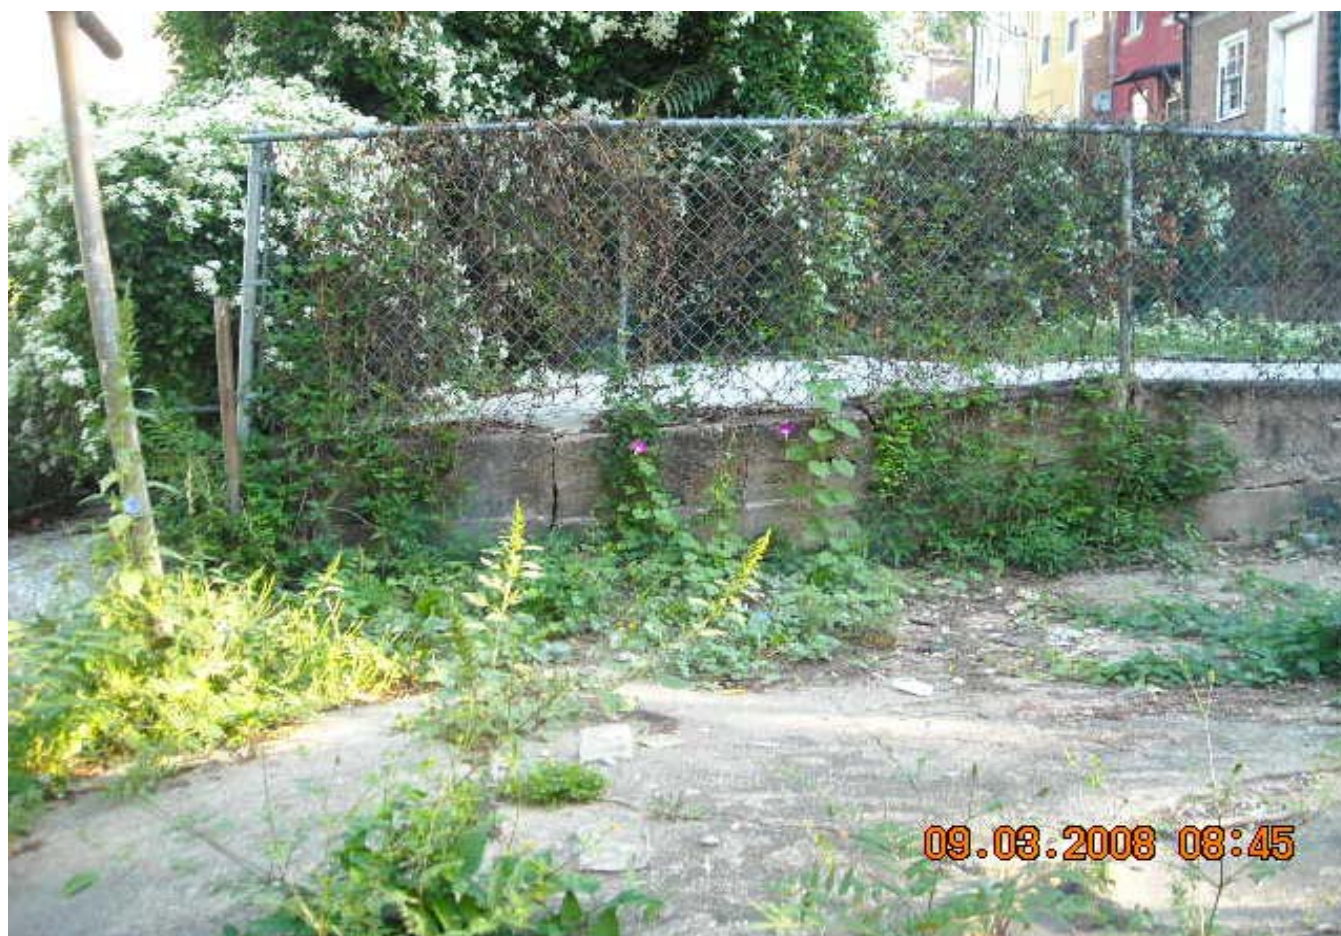
Photograph No: OB02-01
Filename: 1029-589_OB02-01.jpg

Unique Test ID: 589	Date: 09/03/2008	Basin: LL - 44	Manhole ID: S19I__010MH
Defect No: OB02	Supervisor: E.R.	Crew: 04	Dye Test Recommended: N
Location: 14 S. PAYSON ST.			
Source Type: 02 Service Line		Sector: 02 Private	
Location: 08 Yard - Back		Severity: 03 Moderate	Drainage Area: 30
Comments: SMOKE IS COMING FROM GROUND IN MULTIPLE PLACES ALONG YARD SIDE BELOW FENCE.

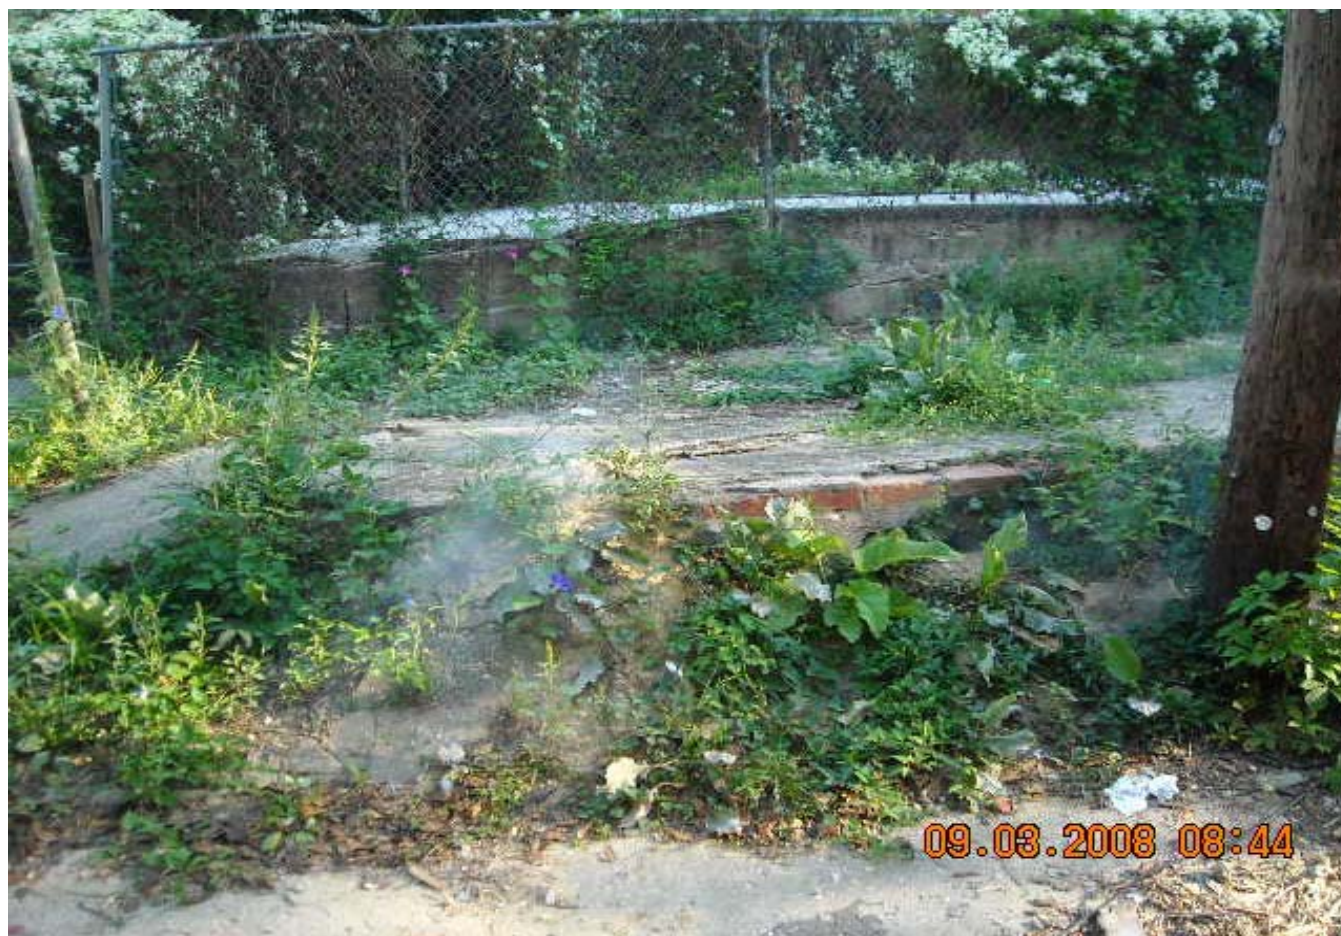
Photograph No: OB03-01
Filename: 1029-589_OB03-01.jpg

Unique Test ID: 589	Date: 09/03/2008	Basin: LL - 44	Manhole ID: S19I__010MH
Defect No: OB03	Supervisor: E.R.	Crew: 04	Dye Test Recommended: N
Location: 16 S. PAYSON ST.			
Source Type: 02 Service Line		Sector: 02 Private	
Location: 08 Yard - Back		Severity: 03 Moderate	Drainage Area: 30
Comments: SMOKE IS COMING FROM GROUND IN MULTIPLE PLACES ALONG YARD SIDE.
